**Flood Control Project Maintenance
Levee Inspections**

Maintenance Issue Types Only, Levee Inspection Report By Mile - Spring 2015

Reclamation District No. 2101 Blewett

Waterway	Bank	Unit Miles	Inspection Start/End	Inspector
Unit No. 01 San Joaquin River	Left	3.16	03/26/2015 03/26/2015	Maksim Khashchuk

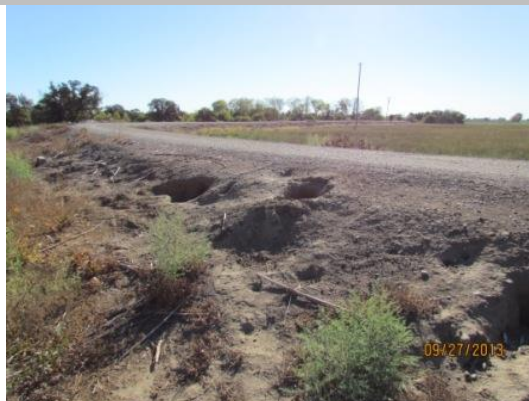
Photo 1 of 1 : SP_2015_RD2101_326_12_20150317_00005.jpg

LM Start	0.04	Rating **	M	Issue No.	12
LM End	0.04	Issue Type +	Ma	Location *	WS
Category	Earthen Levee			GPS Latitude/Longitude	
				Start	End
Item	Animal Control			37.657648 °	37.657648 °
				-121.253812 °	-121.253812 °
DWR ID	DWR_RD2101_01_s_2012_12				
Action/Comments					
No rodents visible, but rodent burrows visible; need to backfill and compact or grout burrows.

View of rodent holes on waterward slope, facing upstream.

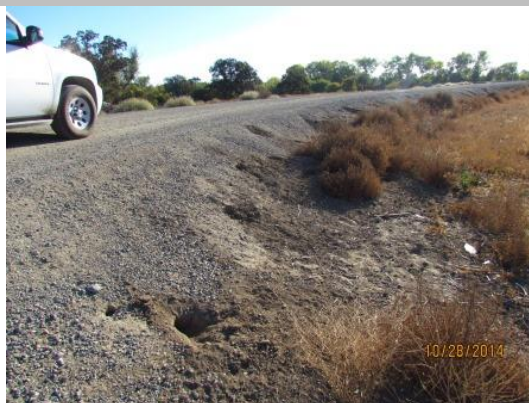
Photo 1 of 1 : SP_2015_RD2101_326_16_20150317_00007.jpg

LM Start	0.08	Rating **	M	Issue No.	16
LM End	0.08	Issue Type +	Ma	Location *	LS
Category	Earthen Levee			GPS Latitude/Longitude	
				Start	End
Item	Animal Control			37.657811 °	37.657811 °
				-121.253269 °	-121.253269 °
DWR ID	DWR_RD2101_01_s_2013_16				
Action/Comments					
No rodents visible, but rodent burrows visible; need to backfill and compact or grout burrows.					
Inspector Comments: Continue rodent extermination and backfilling the rodent burrows.

View of rodent burrows on the landside levee slope.

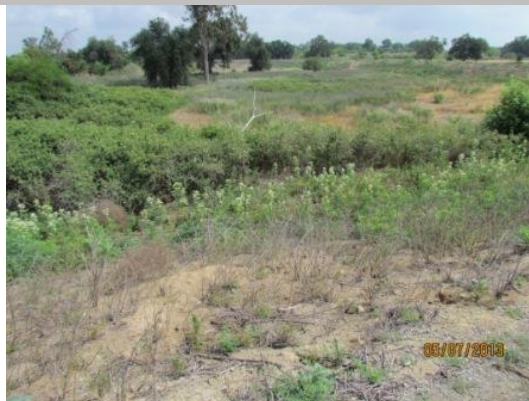
Photo 1 of 1 : SP_2015_RD2101_326_26_20150317_00012.jpg

LM Start	0.70	Rating **	M	Issue No.	26
LM End	0.70	Issue Type +	Ma	Location *	WS
Category	Earthen Levee			GPS Latitude/Longitude	
				Start	End
Item	Animal Control			37.659907 °	37.659907 °
				-121.244219 °	-121.244219 °
DWR ID	DWR_RD2101_01_s_2013_26				
Action/Comments					
Exterminate rodents and backfill and compact or grout burrows.

View of the rodent burrows on the waterside levee slope.

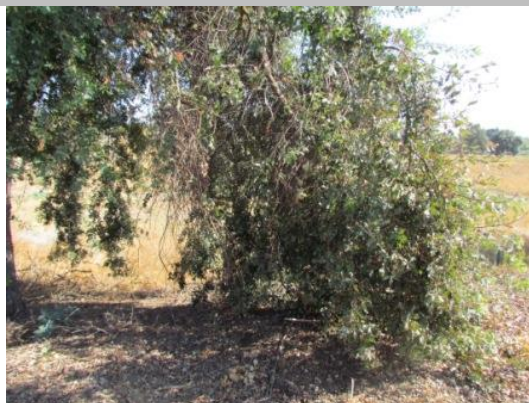
Photo 1 of 1 : SP_2015_RD2101_326_11_20150317_00004.jpg

LM Start	0.75	Rating **	M	Issue No.	11
LM End	0.75	Issue Type +	Ma	Location *	WS
Category	Earthen Levee			GPS Latitude/Longitude	
				Start	End
Item	Trim / Thin Trees			37.659705 °	37.659705 °
				-121.243306 °	-121.243306 °
DWR ID	DWR_RD2101_01_f_2012_11				
Action/Comments					
Trim trees to at least five feet above ground level.					
Inspector Comments: Trim tree to allow access and visibility.

View of tree branches obstructing waterside slope.

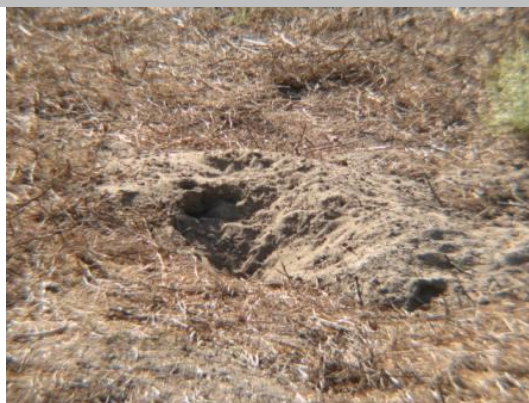
Photo 1 of 1 : SP_2015_RD2101_326_3_20150317_00002.jpg

LM Start	0.87	Rating **	M	Issue No.	3
LM End	0.87	Issue Type +	Ma	Location *	LS
Category	Earthen Levee			GPS Latitude/Longitude	
				Start	End
Item	Animal Control			37.658663 °	37.658663 °
				-121.241750 °	-121.241750 °
DWR ID	DWR_RD2101_01_s_2012_3				
Action/Comments					
No rodents visible, but rodent burrows visible; need to backfill and compact or grout burrows.

11/02/2011 Active rodent burrow.

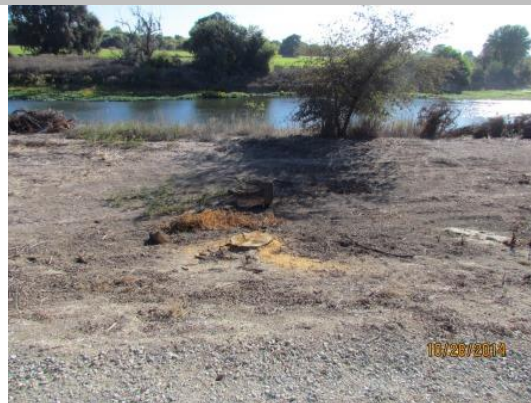
Photo 1 of 1 : SP_2015_RD2101_326_33_20150317_00018.jpg

LM Start	1.02	Rating **	N	Issue No.	33
LM End	1.02	Issue Type +	Ma	Location *	WS
Category	Earthen Levee			GPS Latitude/Longitude	
				Start	End
Item	Trim / Thin Trees			37.656745 °	37.656745 °
				-121.241104 °	-121.241104 °
DWR ID	DWR_RD2101_01_f_2014_33				
Action/Comments					
Tree stumps.

View of the tree stump at the waterside levee toe.

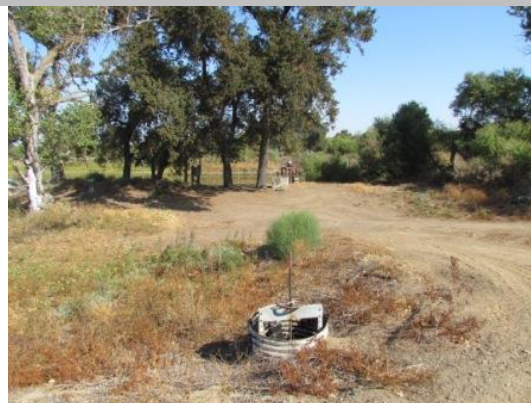
Photo 1 of 1 : SP_2015_RD2101_326_13_20150317_00006.jpg

LM Start	1.59	Rating **	A/W	Issue No.	13
LM End	1.59	Issue Type +	Ma	Location *	WS
Category	Earthen Levee			GPS Latitude/Longitude	
				Start	End
Item	Encroachments			37.651555 °	37.651555 °
				-121.234319 °	-121.234319 °
DWR ID	DWR_RD2101_01_s_2012_13				
Action/Comments					
Pipe Inspector Comments: Pipe penetrates through levee. Closure valve on water side slope.

Photo of pump in background and CMP riser with valve in foreground.

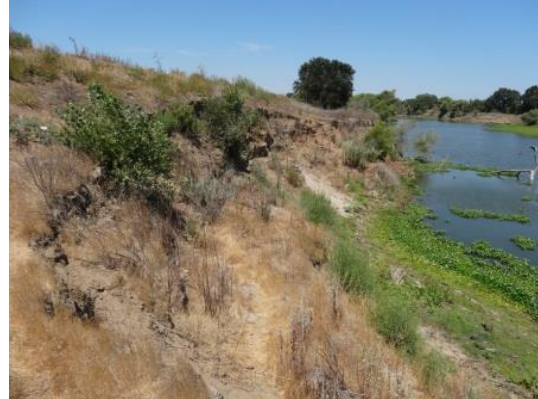
Photo 1 of 1 : SP_2015_RD2101_326_1_20150317_00001.jpg

LM Start	1.90	Rating **	U	Issue No.	1
LM End	1.90	Issue Type +	Ma	Location *	WS
Category	Supplemental			GPS Latitude/Longitude	
				Start	End
Item	DWR Erosion Survey			37.650259 °	37.650259 °
				-121.228961 °	-121.228961 °
DWR ID	DWR_RD2101_01_s _ 2015_1				
Action/Comments					
Inspector Comments: 07/17/2014: No significant change observed. 09/20/2013: Site has been visited. There are signs of further erosion development along the levee slope and toe. 07/18/2012: The erosion has further developed toward levee crown. Vegetation has been removed. 08/18/2011: The erosion progressed significantly during the past flood season. The levee toe along the erosion site was washed away, and the erosion has cut the levee structure up to the point about 1/3 of the levee slope. The scarp height is approximately 17 feet. Very dense vegetation and trees are visible. 10/19/2010: No significant change observed on site. Remaining levee berm topsoil is of silty sand mixture. The erosion is near the downstream transition. An eddy has formed, and has scoured away a 100-foot section of the bank, possibly encroaching into the levee prism. Vegetation on site includes willows, oak, and cotton wood located from the bench to the toe. On the landside are rows of corn crop. 08/05/2010: Recommended for Repair, per CLRO. 2009: Site recommended as annual assessment and monitoring if critical erosion site, per CLRO CES Evaluation 2008 Report; an eddy has formed, eroding bank and intruding into the levee prism; Site # is the same as RM76.3, LM1.89; previously rated "U". 08/30/2007: Recommended for short list of immediate repair sites; silty sand levee material. [2014 Site ID:RD2101U01RM73.92]

Upstream view of the erosion.

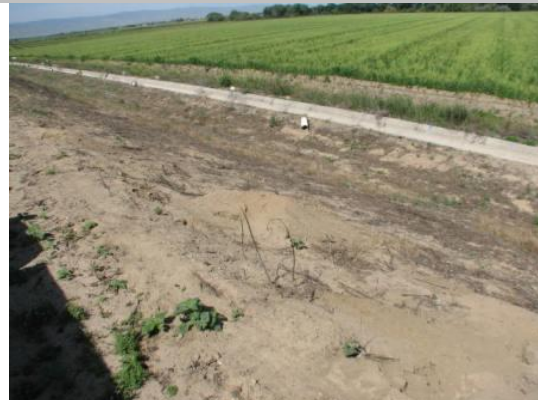
Photo 1 of 1 : SP_2015_RD2101_326_30_20150317_00017.jpg

LM Start	2.36	Rating **	M	Issue No.	30
LM End	2.36	Issue Type +	Ma	Location *	LS
Category	Earthen Levee			GPS Latitude/Longitude	
				Start	End
Item	Animal Control			37.645785 °	37.645785 °
				-121.226337 °	-121.226337 °
DWR ID	DWR_RD2101_01_s _ 2012_30				
Action/Comments					
Exterminate rodents and backfill and compact or grout burrows.

View of levee material removed by rodent activity on landside slope, facing upstream. 05/02/2012

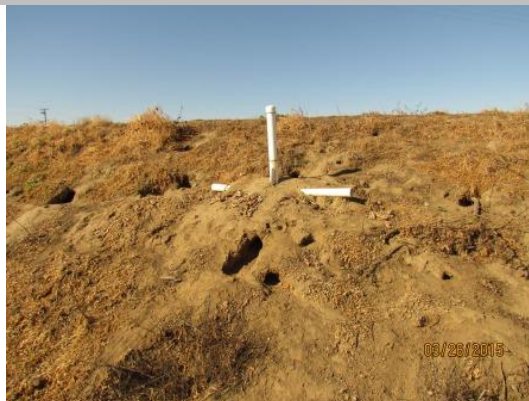
Photo 1 of 1 : SP_2015_RD2101_326_27_20150330_00026.jpg

LM Start	2.83	Rating **	U	Issue No.	27
LM End	2.83	Issue Type +	Ma	Location *	WS
Category	Earthen Levee			GPS Latitude/Longitude	
				Start	End
Item	Animal Control			37.640425 °	37.640425 °
				-121.230139 °	-121.230139 °
DWR ID	DWR_RD2101_01_s _ 2012_27				
Action/Comments					
No rodents visible, but rodent burrows visible; need to backfill and compact or grout burrows.					
Inspector Comments: Burrows on both sides of levee. Backfill the burrows to restore the levee to original condition.

View of multiple rodent holes on the levee slope.

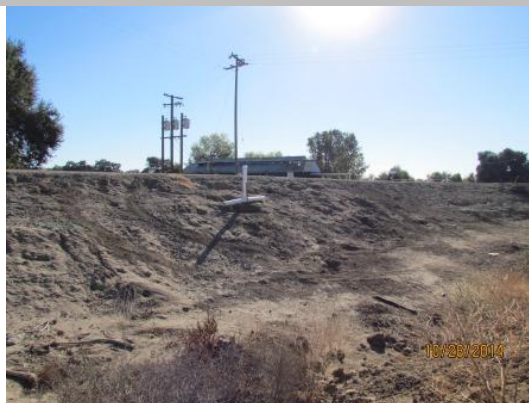
Photo 1 of 1 : SP_2015_RD2101_326_28_20150317_00014.jpg

LM Start	2.85	Rating **	A/W	Issue No.	28
LM End	2.85	Issue Type +	Ma	Location *	LS
Category	Earthen Levee			GPS Latitude/Longitude	
				Start	End
Item	Animal Control			37.640134 °	37.640134 °
				-121.230019 °	-121.230019 °
DWR ID	DWR_RD2101_01_s _ 2012_28				
Action/Comments					
No rodents visible, but rodent burrows visible; need to backfill and compact or grout burrows.					
Inspector Comments: Rodent holes were backfilled. Continue to monitor the area and exterminate the rodents.

View of numerous rodent holes with bait stations present.

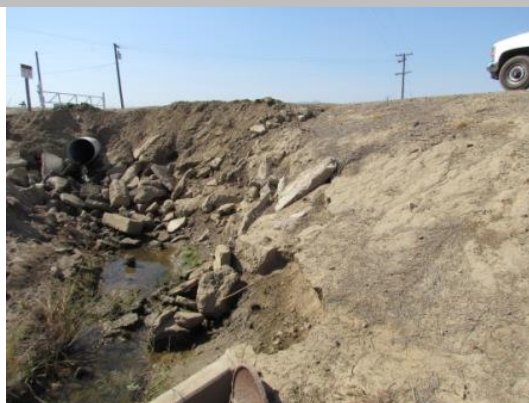
Photo 1 of 2 : SP_2015_RD2101_326_29_20150317_00015.jpg

LM Start	2.87	Rating **	M	Issue No.	29
LM End	2.87	Issue Type +	Ma	Location *	WS
Category	Earthen Levee			GPS Latitude/Longitude	
				Start	End
Item	Erosion / Bank Caving			37.639852 °	37.639852 °
				-121.229980 °	-121.229980 °
DWR ID	DWR_RD2101_01_s _ 2012_29				
Action/Comments					
Schedule repair of erosion site prior to the next inspection.

View of repaired site, but it appears that erosion is still occurring.
09/25/2012

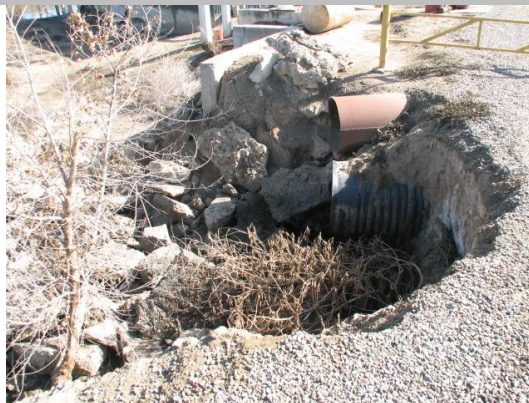
Photo 2 of 2 : SP_2015_RD2101_326_29_20150317_00016.jpg

LM Start	2.87	Rating **	M	Issue No.	29 (cont)	
LM End	2.87	Issue Type +	Ma	Location *	WS	
Category	Earthen Levee			GPS Latitude/Longitude		
				Start		End
Item	Erosion / Bank Caving			37.639852 °	37.639852 °	
				-121.229980 °	-121.229980 °	
DWR ID	DWR_RD2101_01_s _ 2012_29					
Action/Comments						
Schedule repair of erosion site prior to the next inspection.

Levee slope is being eroded at this location. Repair needed to preserve access road.

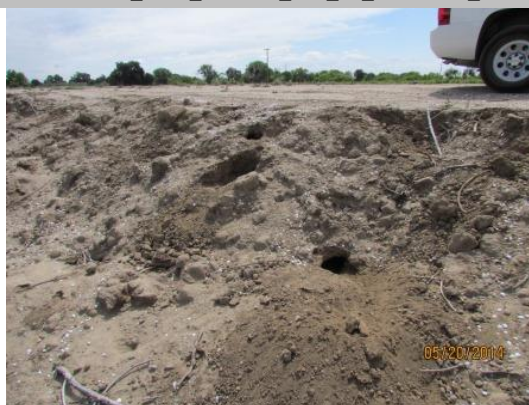
Photo 1 of 1 : SP_2015_RD2101_326_17_20150317_00008.jpg

LM Start	2.98	Rating **	M	Issue No.	17
LM End	2.98	Issue Type +	Ma	Location *	LS
Category	Earthen Levee			GPS Latitude/Longitude	
				Start	End
Item	Animal Control			37.638760 °	37.638760 °
				-121.231341 °	-121.231341 °
DWR ID	DWR_RD2101_01_s _ 2012_17				
Action/Comments					
Exterminate rodents and backfill and compact or grout burrows. Inspector Comments: Active burrows with rodents present.

Numerous burrows present, some already caving in, others are active.

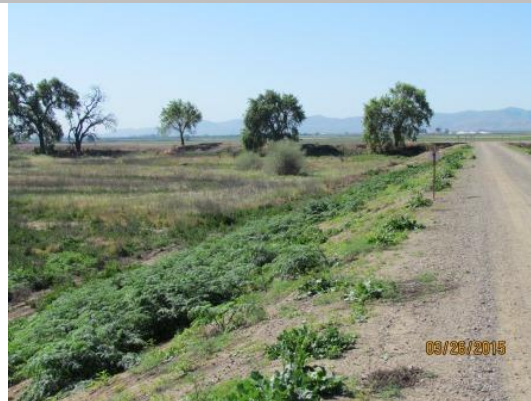
Photo 1 of 1 : SP_2015_RD2101_327_1_20150330_00003.jpg

LM Start	0.10	Rating **	M	Issue No.	1
LM End	0.10	Issue Type +	Ma	Location *	WS
Category	Earthen Levee			GPS Latitude/Longitude	
				Start	End
Item	Vegetation			37.661185 °	37.661185 °
				-121.243088 °	-121.243088 °
DWR ID	DWR_RD2101_02_f_2014_1				
Action/Comments					
Control annual grass and weeds on the levee slopes and easements.

View of the vegetation on the waterside levee slope.

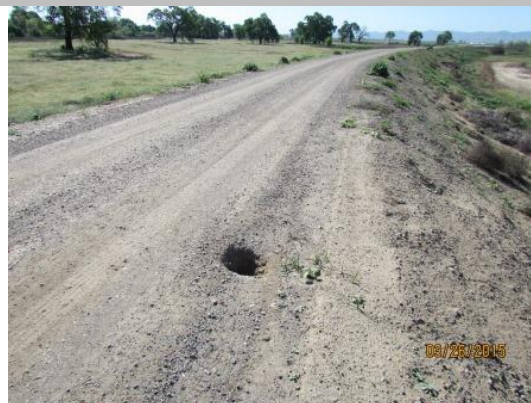
Photo 1 of 1 : SP_2015_RD2101_327_2_20150330_00004.jpg

LM Start	0.23	Rating **	M	Issue No.	2
LM End	0.23	Issue Type +	Ma	Location *	CR
Category	Earthen Levee			GPS Latitude/Longitude	
				Start	End
Item	Animal Control			37.662968 °	37.662968 °
				-121.242674 °	-121.242674 °
DWR ID	DWR_RD2101_02_f_2013_2				
Action/Comments					
No rodents visible, but rodent burrows visible; need to backfill and compact or grout burrows.					
Inspector Comments: Backfill and compact the rodent holes to restore the levee to original condition.

View of the rodent burrow on the levee crown.
